**Subject: Removal Site Evaluation and Preliminary Assessment
Rotary Drilling Supply Site, Inc., Crystal City, Missouri
CERCLIS ID No: MON000706201
U.S. EPA Region 7 START, Contract No. EP-S7-06-01, Task Order No. 0214
Task Monitors: Jamie Bernard-Drakey, EPA Site Assessment Manager
Jim Silver, On-Scene Coordinator**

**REMOVAL SITE EVALUATION/PRELIMINARY ASSESSMENT
ROTARY DRILLING SUPPLY SITE, INC.
CRYSTAL CITY, MISSOURI
CERCLIS ID No. MON000706201**

Contract No. EP-S7-06-01, Task Order No. 0214

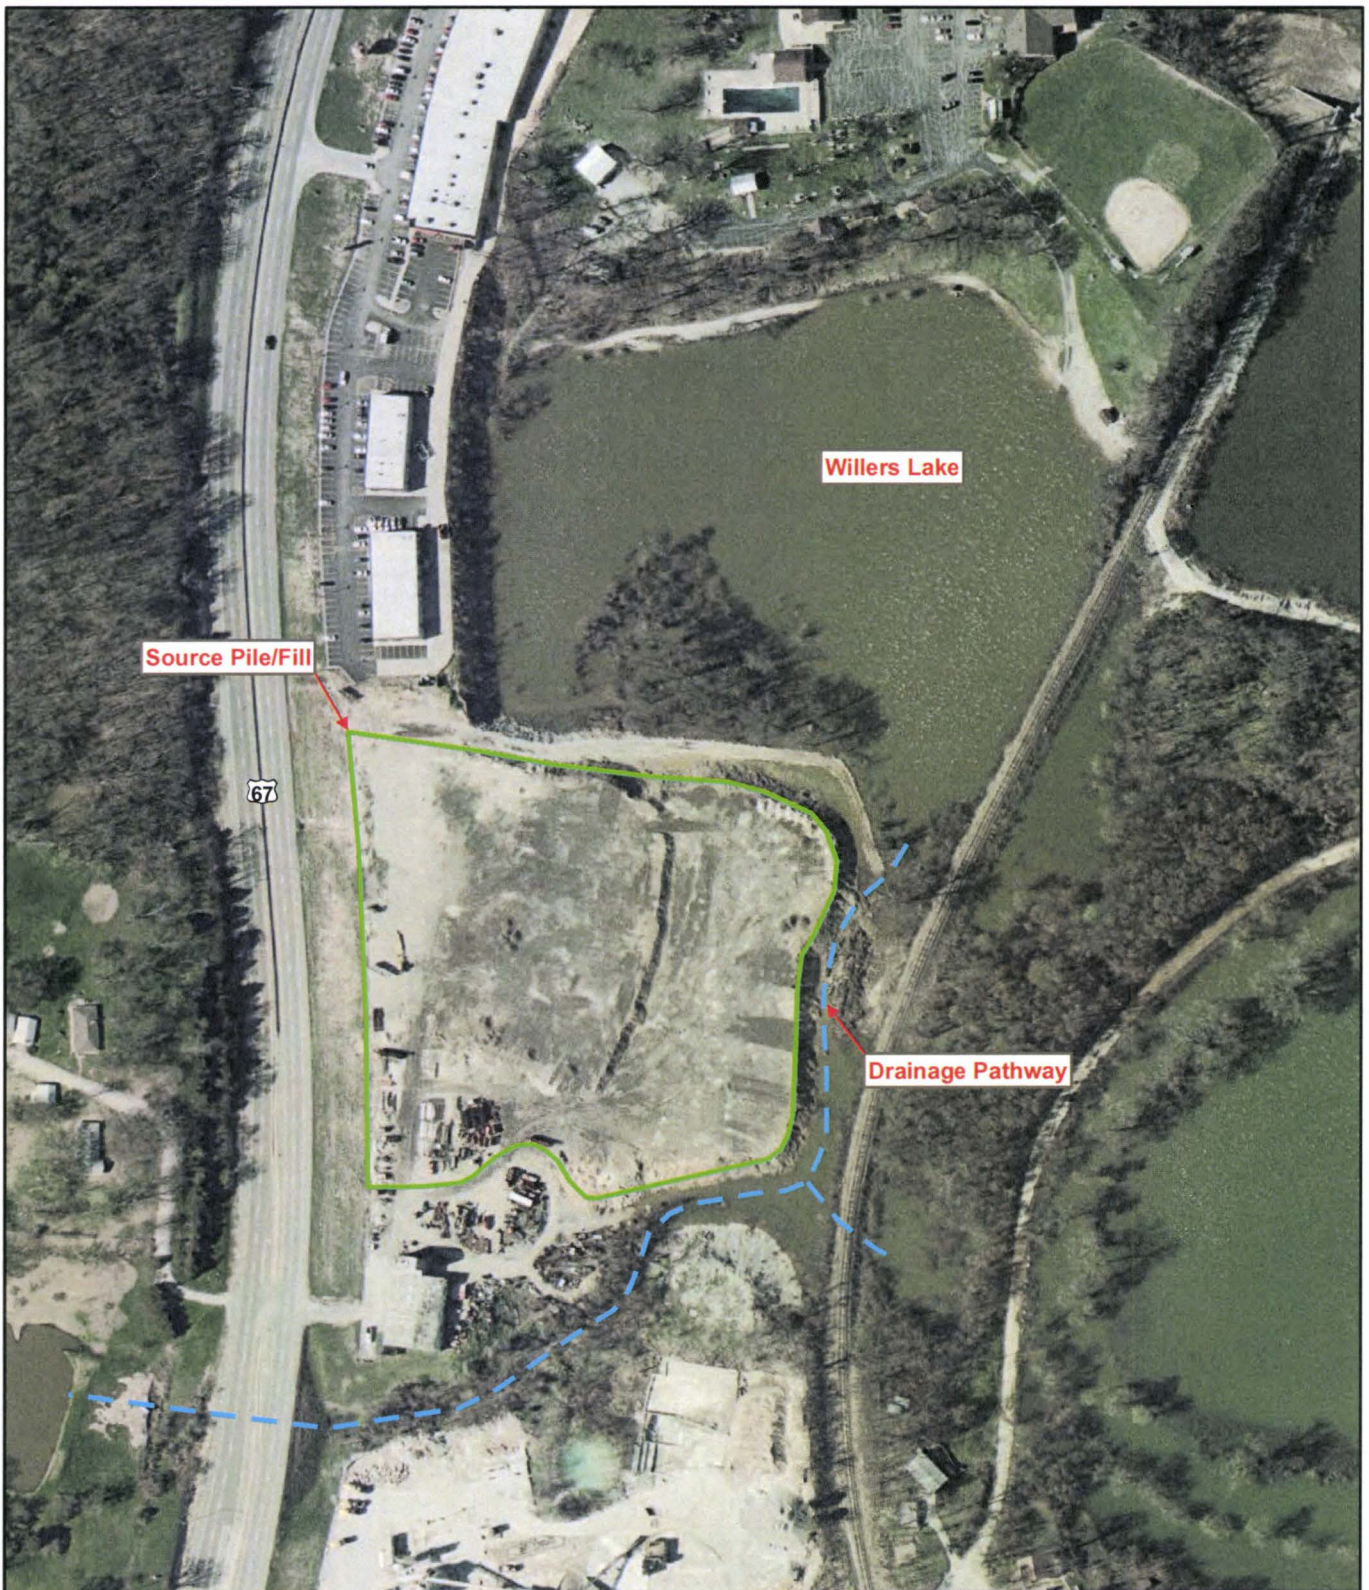
Figure 2
Site Layout Map

- Drainage pathway
- Source pile/fill

A Site Layout Map is included as Figure 2 in Appendix A. Photographs documenting site activities are included in Appendix B, and sampling activities were recorded in a site logbook, a copy of which is included in Appendix C. Geoprobe[®] boring logs are included in Appendix D. Samples for analytical services request (ASR) 5198 were shipped overnight on February 16, 2011, via Federal Express to the EPA Region 7 laboratory. Field sheets and chain-of-custody records are included in Appendix E, and analytical results are included in Appendix F.

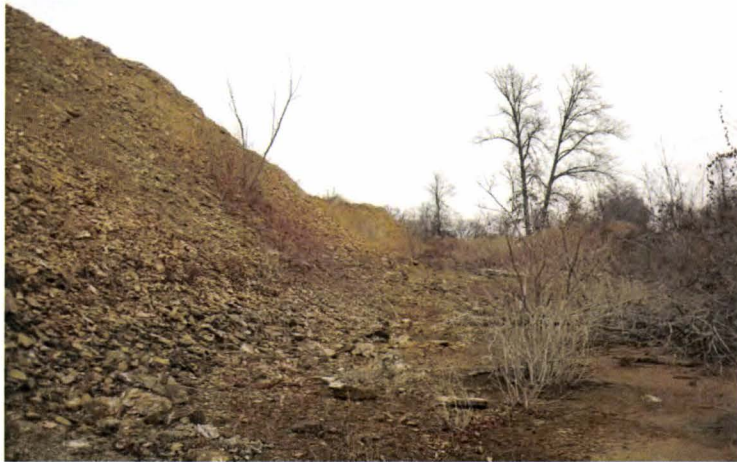
EPA TASK ORDER NO. 9004.L.10.0214.000 Direction: Northeast	DESCRIPTION	This photograph shows the coal fly ash pile looking northeast.	1
	CLIENT	EPA	Date 11/30/10
	PHOTOGRAPHER	Ann Marie Pohlman

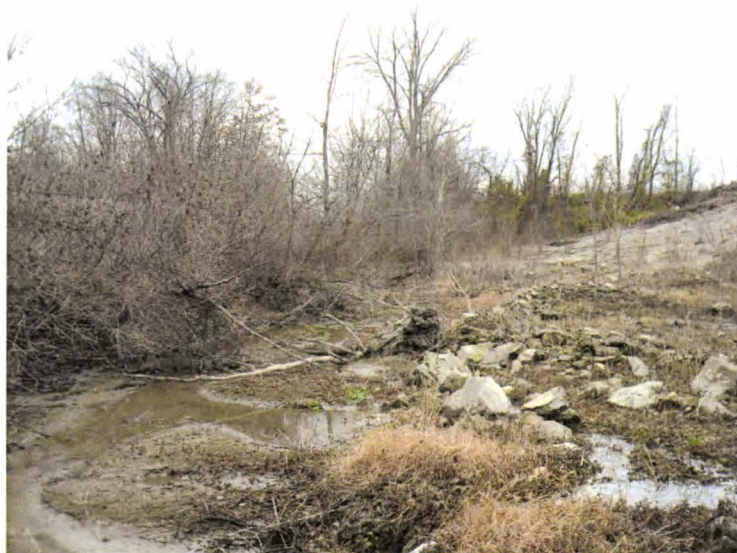
EPA TASK ORDER NO. 9004.L.10.0214.000 Direction: South	DESCRIPTION	This photograph shows the drainage pathway on the east side of the property.	2
	CLIENT	EPA	Date 11/30/10
	PHOTOGRAPHER	Ann Marie Pohlman

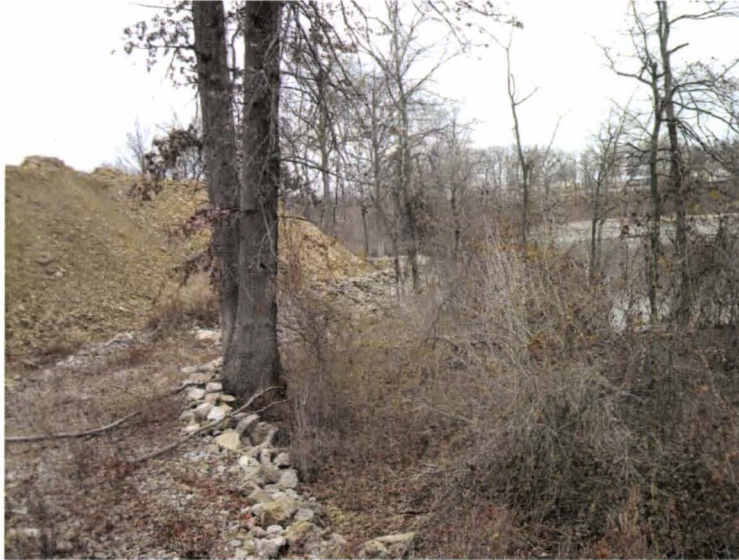
EPA TASK ORDER NO. 9004.L.10.0214.000 Direction: Northwest	DESCRIPTION	This photograph shows a berm between the coal fly ash pile and the Elks' pond (Willers Lake).	3
	CLIENT	EPA	Date 11/30/10
	PHOTOGRAPHER	Ann Marie Pohlman

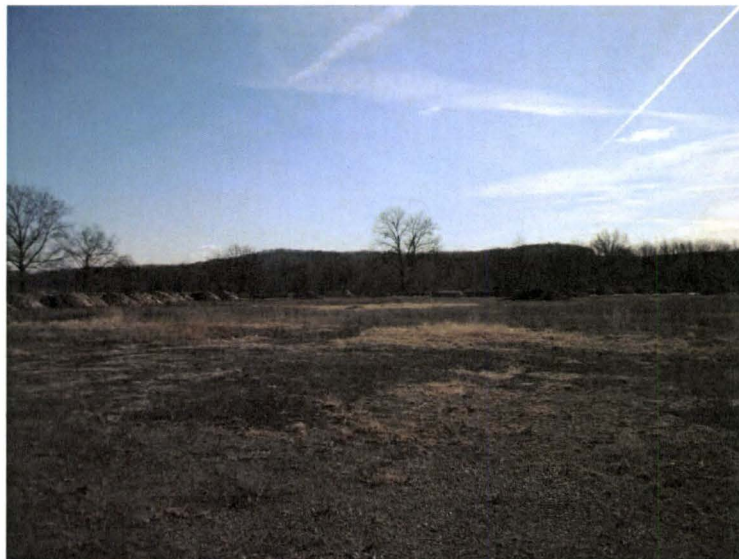
EPA TASK ORDER NO. 9004.L.10.0214.000 Direction: East	DESCRIPTION	This photograph shows the coal fly ash pile, facing east.	4
	CLIENT	EPA	Date 2/14/11
	PHOTOGRAPHER	Ann Marie Pohlman

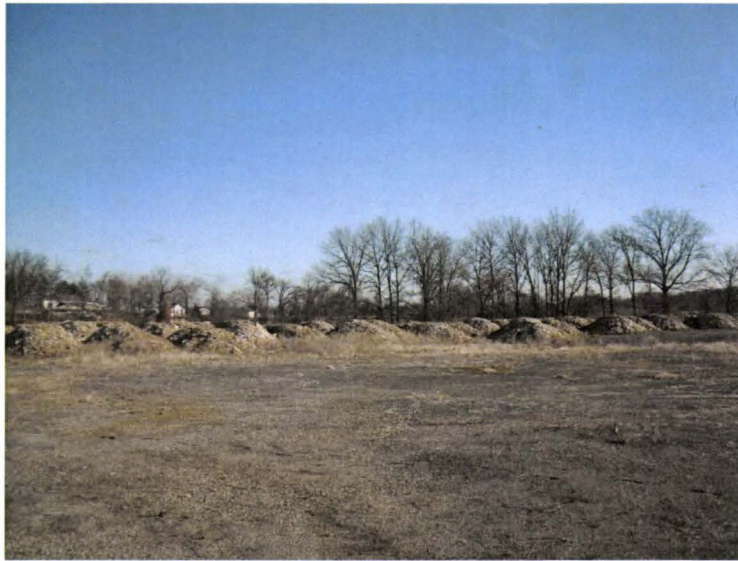
EPA TASK ORDER NO. 9004.L.10.0214.000 Direction: Northeast	DESCRIPTION	This photograph shows smaller coal fly ash piles on the property, facing northeast.	5
	CLIENT	EPA	Date 2/14/11
	PHOTOGRAPHER	Ann Marie Pohlman

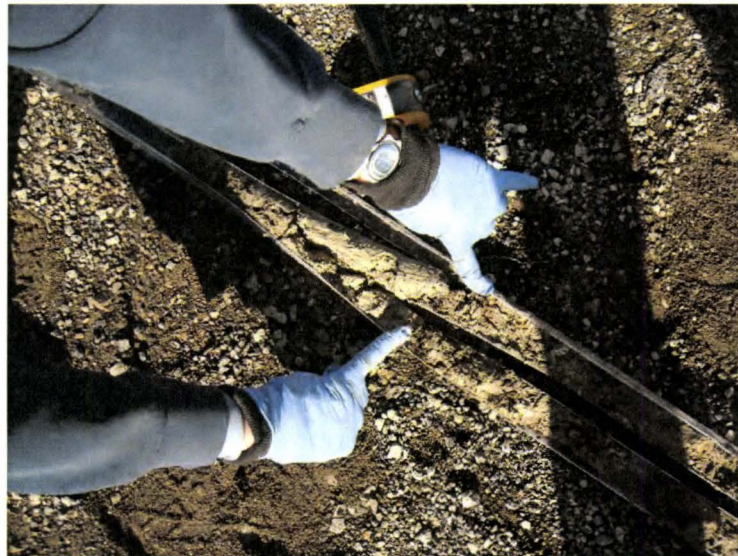
EPA TASK ORDER NO. 9004.L.10.0214.000 Direction: NA	DESCRIPTION	This photograph shows a Geoprobe soil sample from RDS-SB-2, from a depth of 0 to 4 feet below ground surface (bgs).	6
	CLIENT	EPA	Date 2/14/11
	PHOTOGRAPHER	Ann Marie Pohlman

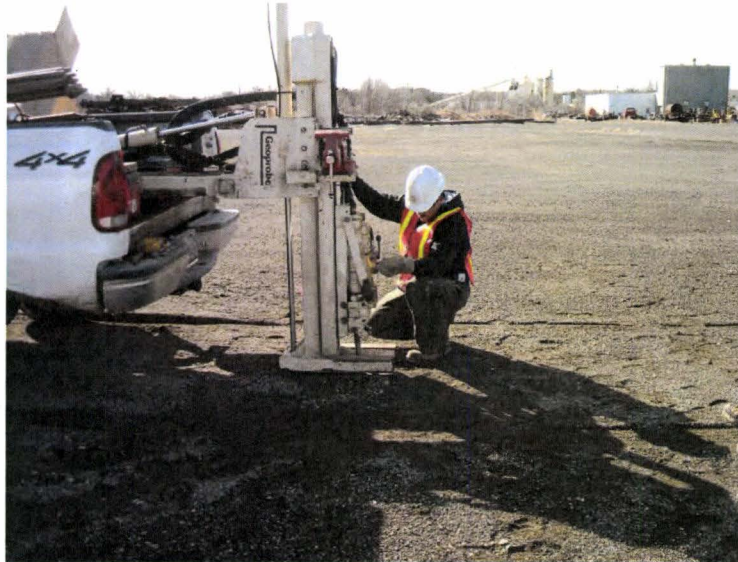
EPA TASK ORDER NO. 9004.L.10.0214.000 Direction: South	DESCRIPTION	This photograph shows Geoprobe sampling at location RDS-SB-2.	7
	CLIENT	EPA	Date 2/14/11
	PHOTOGRAPHER	Ann Marie Pohlman

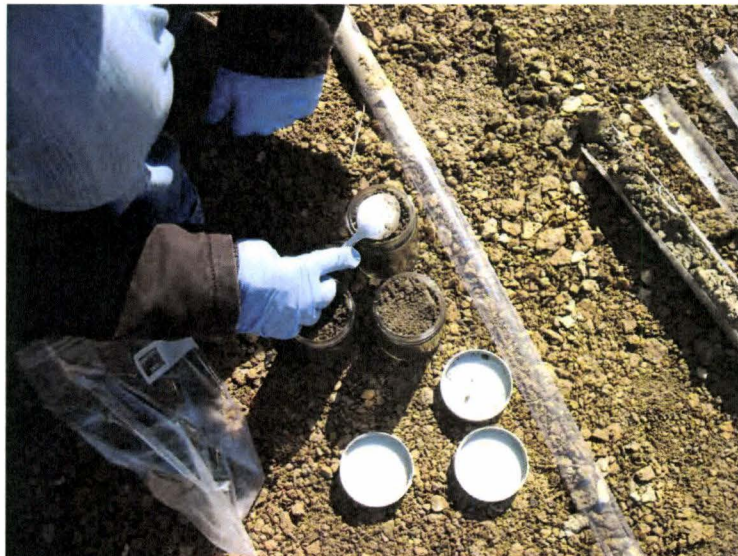
EPA TASK ORDER NO. 9004.L.10.0214.000 Direction: NA	DESCRIPTION	This photograph shows a Geoprobe soil sample being collected at RDS-SB-3, from a depth of 7 to 9 feet bgs.	8
	CLIENT	EPA	Date 2/14/11
	PHOTOGRAPHER	Ann Marie Pohlman

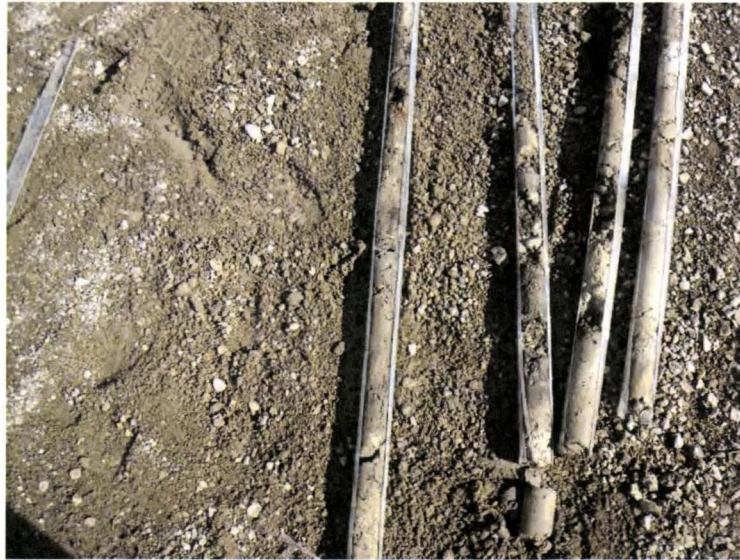
EPA TASK ORDER NO. 9004.L.10.0214.000 Direction: NA	DESCRIPTION	This photograph shows Geoprobe soil samples from RDS-SB-6.	9
	CLIENT	EPA	Date 2/14/11
	PHOTOGRAPHER	Ann Marie Pohlman

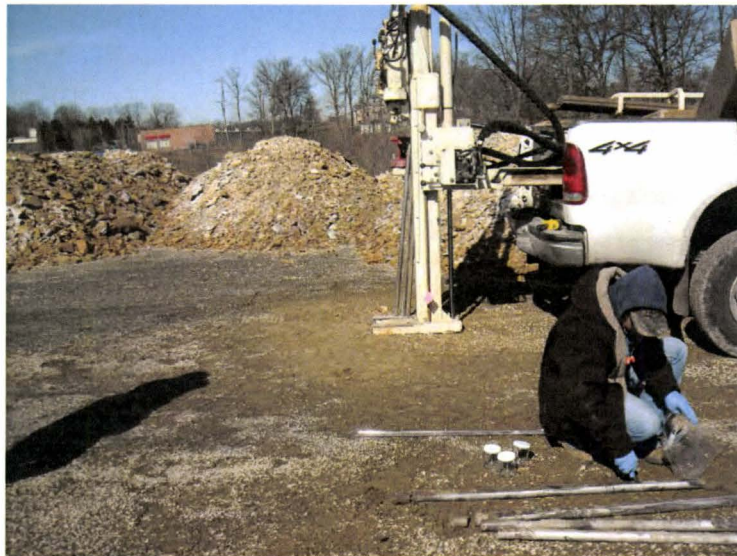
EPA TASK ORDER NO. 9004.L.10.0214.000 Direction: North	DESCRIPTION	This photograph shows a Geoprobe soil sample being collected at RDS-SB-6, from a depth of 13 to 15 feet bgs.	10
	CLIENT	EPA	Date 2/14/11
	PHOTOGRAPHER	Ann Marie Pohlman

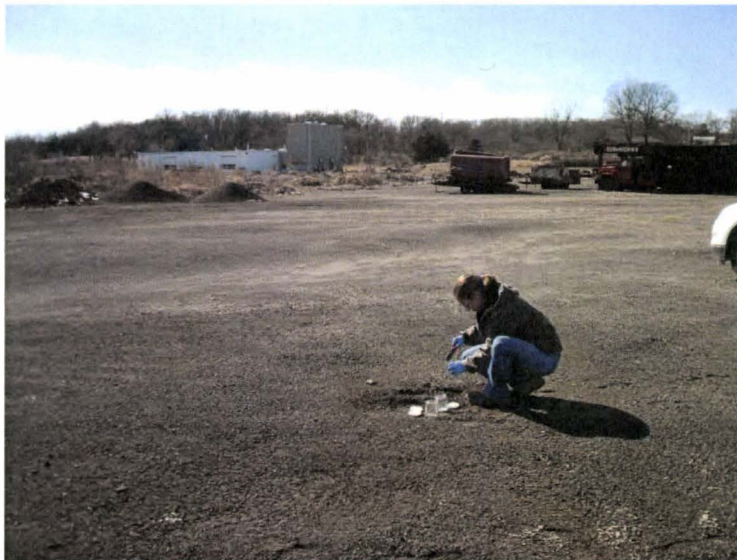
EPA TASK ORDER NO. 9004.L.10.0214.000 Direction: Southwest	DESCRIPTION	This photograph shows a source/fill sample being collected from the fly ash pile.	11
	CLIENT	EPA	Date 2/14/11
	PHOTOGRAPHER	Christy Engemann

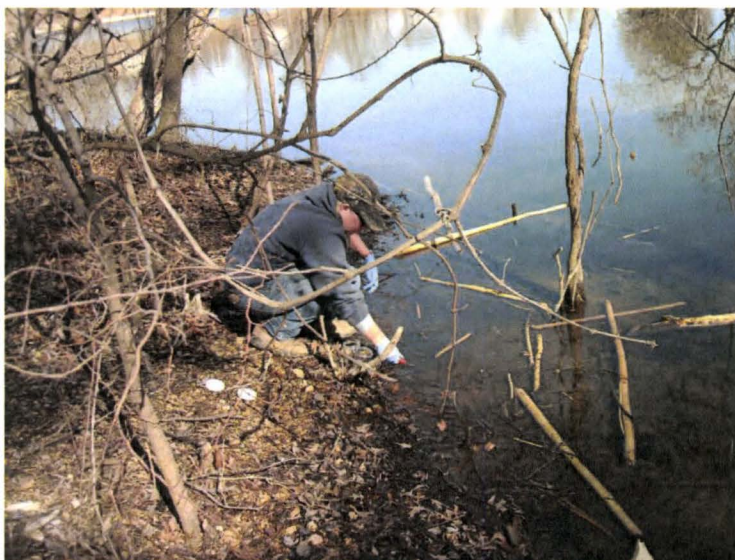
EPA TASK ORDER NO. 9004.L.10.0214.000 Direction: North	DESCRIPTION	This photograph shows a sediment sample being collected from the Elks' pond (Willers Lake).	12
	CLIENT	EPA	Date 2/15/11
	PHOTOGRAPHER	Ann Marie Pohlman

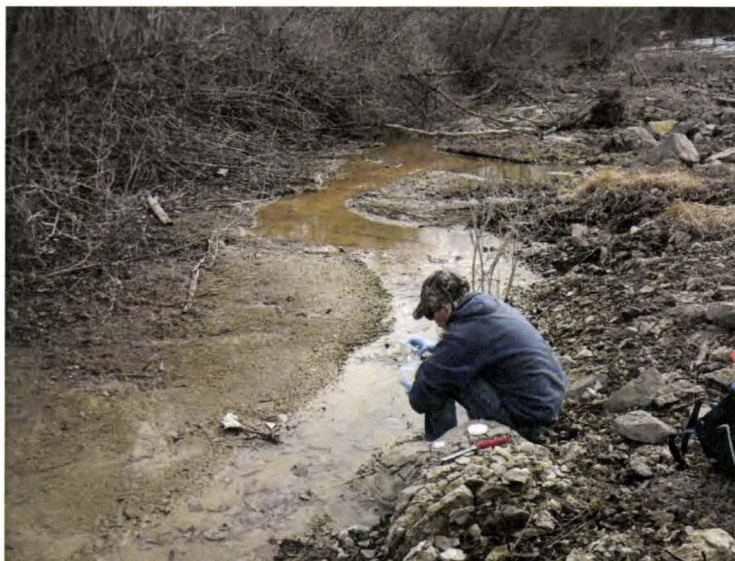
EPA TASK ORDER NO. 9004.L.10.0214.000 Direction: Southeast	DESCRIPTION	This photograph shows a surface water sample being collected from sample location RDS-SW-4.	13
	CLIENT	EPA	Date 2/15/11
	PHOTOGRAPHER	Ann Marie Pohlman

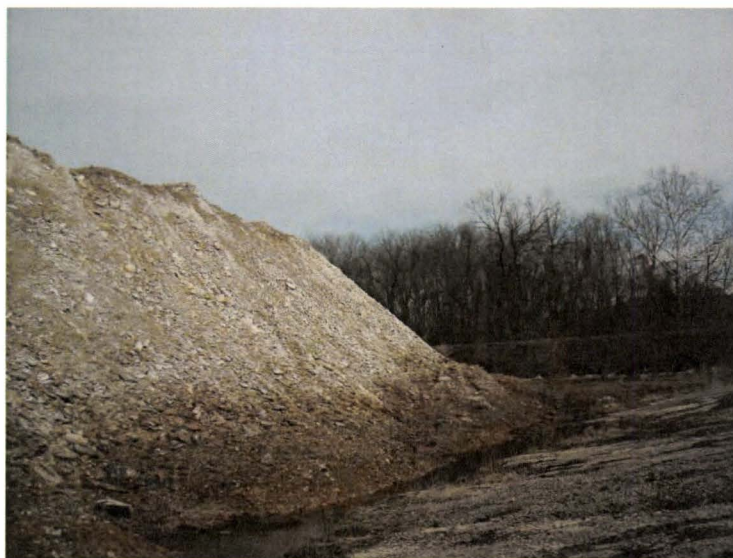
EPA TASK ORDER NO. 9004.L.10.0214.000 Direction: East	DESCRIPTION	This photograph shows the coal fly ash pile and a drainage pathway on the south side of the property.	14
	CLIENT	EPA	Date 2/15/11
	PHOTOGRAPHER	Ann Marie Pohlman

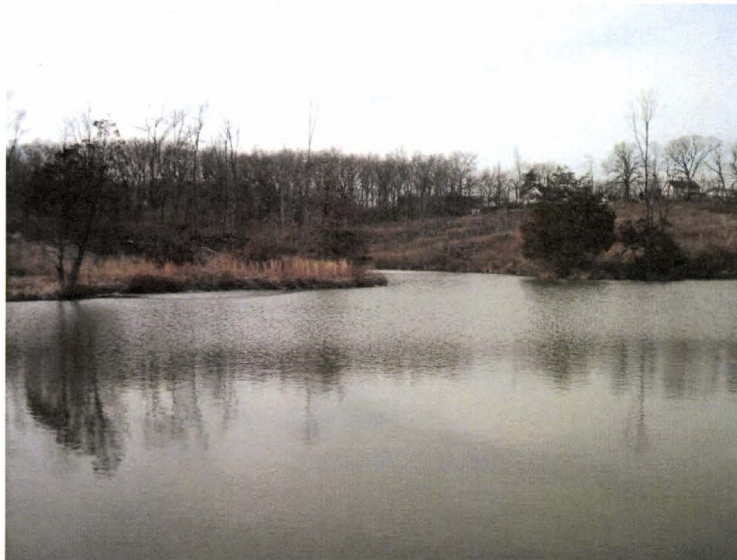
EPA TASK ORDER NO. 9004.L.10.0214.000 Direction: West	DESCRIPTION	This photograph shows the pond on the west side of Highway 61/67, where background sediment and surface water samples were collected.	15
	CLIENT	EPA	Date 2/15/11
	PHOTOGRAPHER	Ann Marie Pohlman

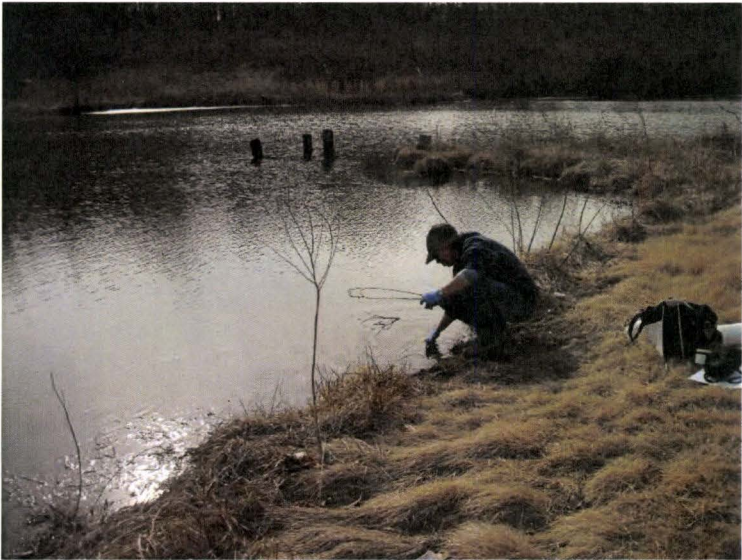
EPA TASK ORDER NO. 9004.L.10.0214.000 Direction: Southwest	DESCRIPTION	This photograph shows a background sediment sample being collected.	16
	CLIENT	EPA	Date 2/15/11
	PHOTOGRAPHER	Ann Marie Pohlman
